INSPECTOR GENERAL  
DEPARTMENT OF DEFENSE  
400 ARMY NAVY DRIVE  
ARLINGTON, VIRGINIA 22202-2884

May 21, 1991

SUBJECT: Report on the Audit of Performance and Reliability of  
Cobra Helicopter Rotor Blades (Report No. 91-082)

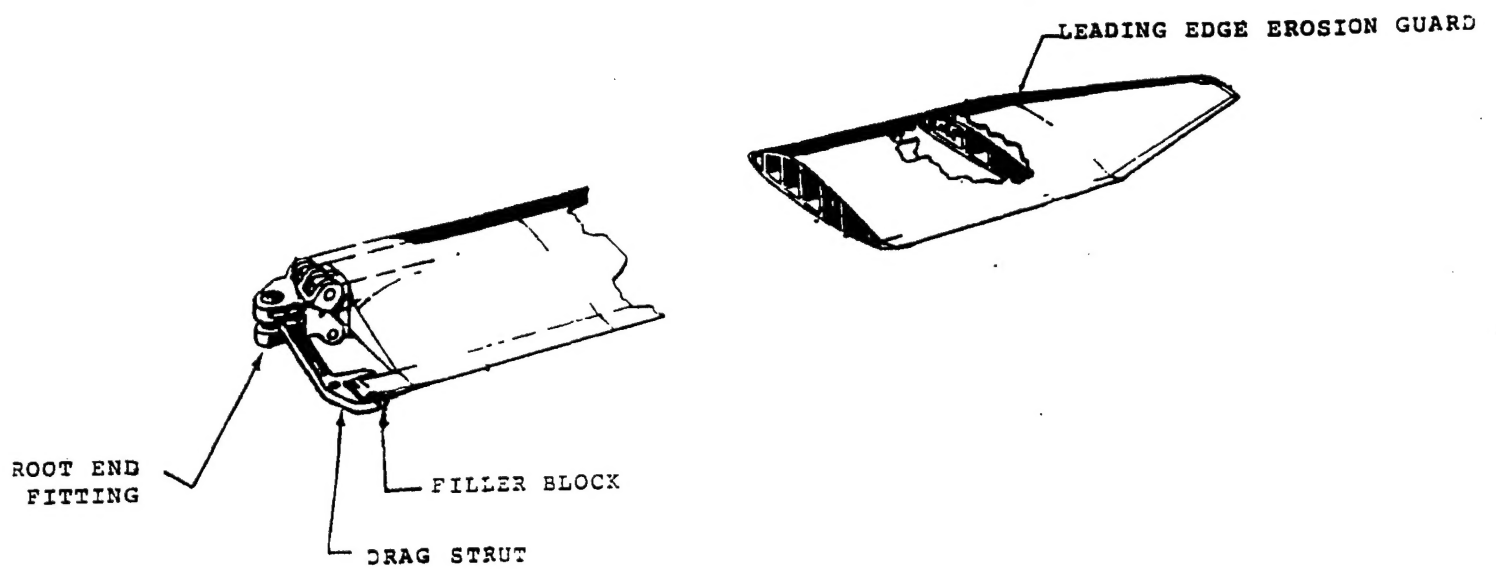
COBRA HELICOPTER K747 MAIN ROTOR BLADE

The K747 blade that is used as the main rotor blade on the AH-1 Cobra Helicopter has had performance and reliability problems. The blade's most serious performance and reliability problems included cracking in the root end fitting and erosion of the blade's leading edge (see Enclosure 1). However, the Government and the blade's manufacturer identified and corrected the problems. The actions appeared to be complete and satisfactory.

The cracks and voids in the blade discovered by Sharpe personnel did not appear to be a problem. Sharpe Army Depot's Nondestructive Evaluation Team discovered cracks and voids in the blade drag strut attaching point (see Enclosure 1) by X-ray imaging in February 1989. Sharpe submitted six Quality Deficiency Reports addressing the deficiencies to the Army Aviation Systems Command. The Army Aviation Systems Command's engineering department replied to Sharpe's deficiency reports in February 1990 stating that the cracks and voids that Sharpe identified were located within the filler block of the blade and that cracks and voids in this area were acceptable. The Army Aviation Systems Command's conclusion was based on an engineering evaluation that the contractor performed and the Government's plant representative monitored. Additionally, in June 1990, the Army Materiel Command informally requested that engineering
